WIND TUNNEL EVALUATION OF CHINOOK WT-11 ULTRA LIGHT

National Aeronautical Establishment

AERONAUTICAL NOTE

NAE-AN-35

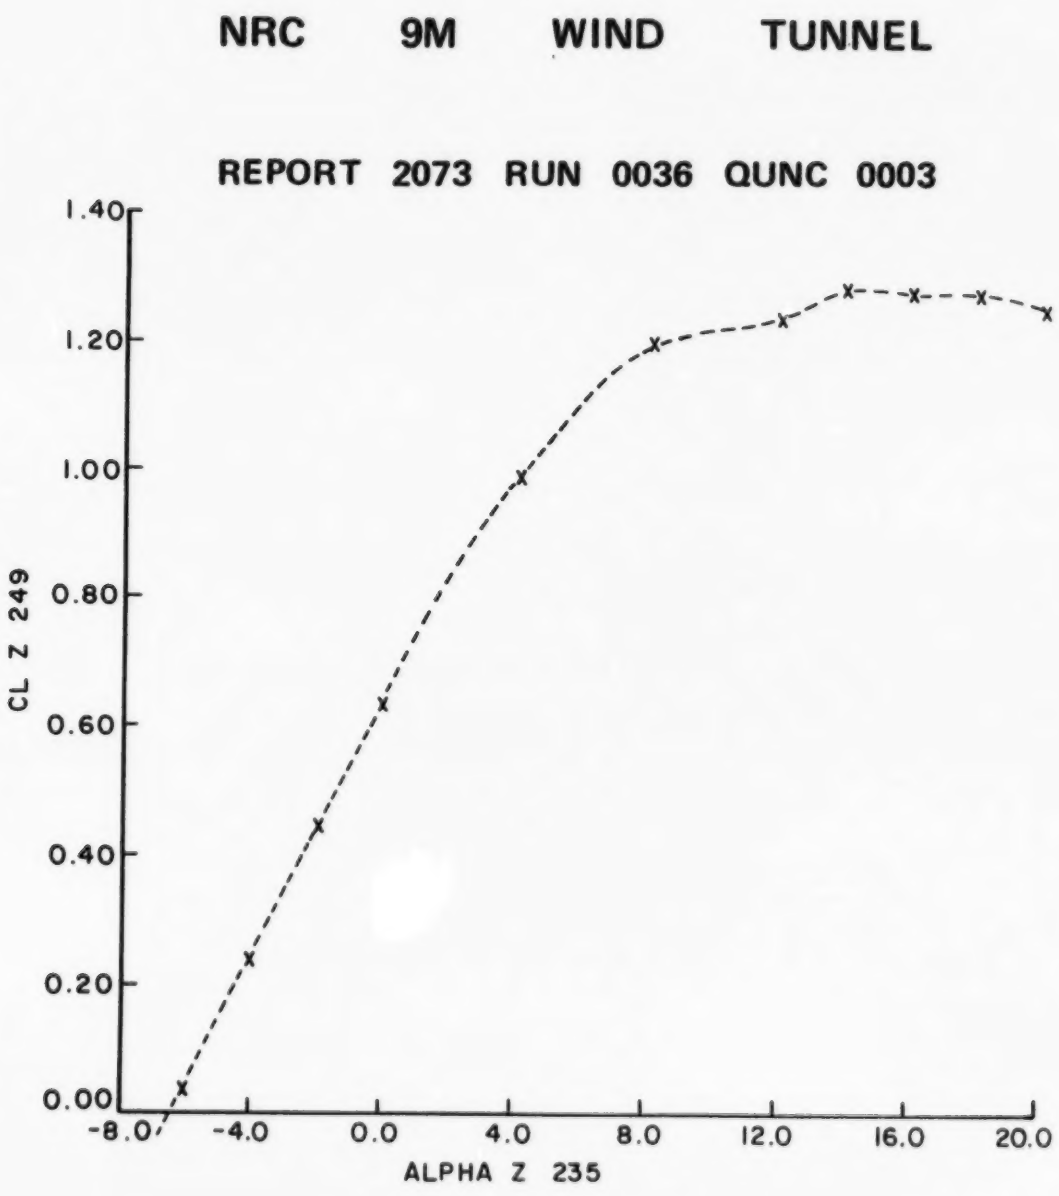
FIG. 6: 9m X 9m TUNNEL PRINTOUT AND C_L VERSUS α CURVE

There is an obvious break in the lift curves around 8 degrees angle of attack. This was typical of all the wing tests. The apparent initial wing stall at all dynamic pressures seemed to occur at a root chord incidence of 8 degrees, indicating a root separation problem.

The comparison with the test results on the UA 81/2 (Fig. 3) and the wing (Fig. 6) show a marked difference in stalling characteristics and maximum lift coefficient. Part of the difference can be explained by three-dimensional effects but the major discrepancies are probably due to poor profile definition as a result of the method of fabrication. Fabric covered wings are not suitable for controlled chordwise pressure distribution airfoils. The lack of precise profile definition defeats the designer's best efforts.

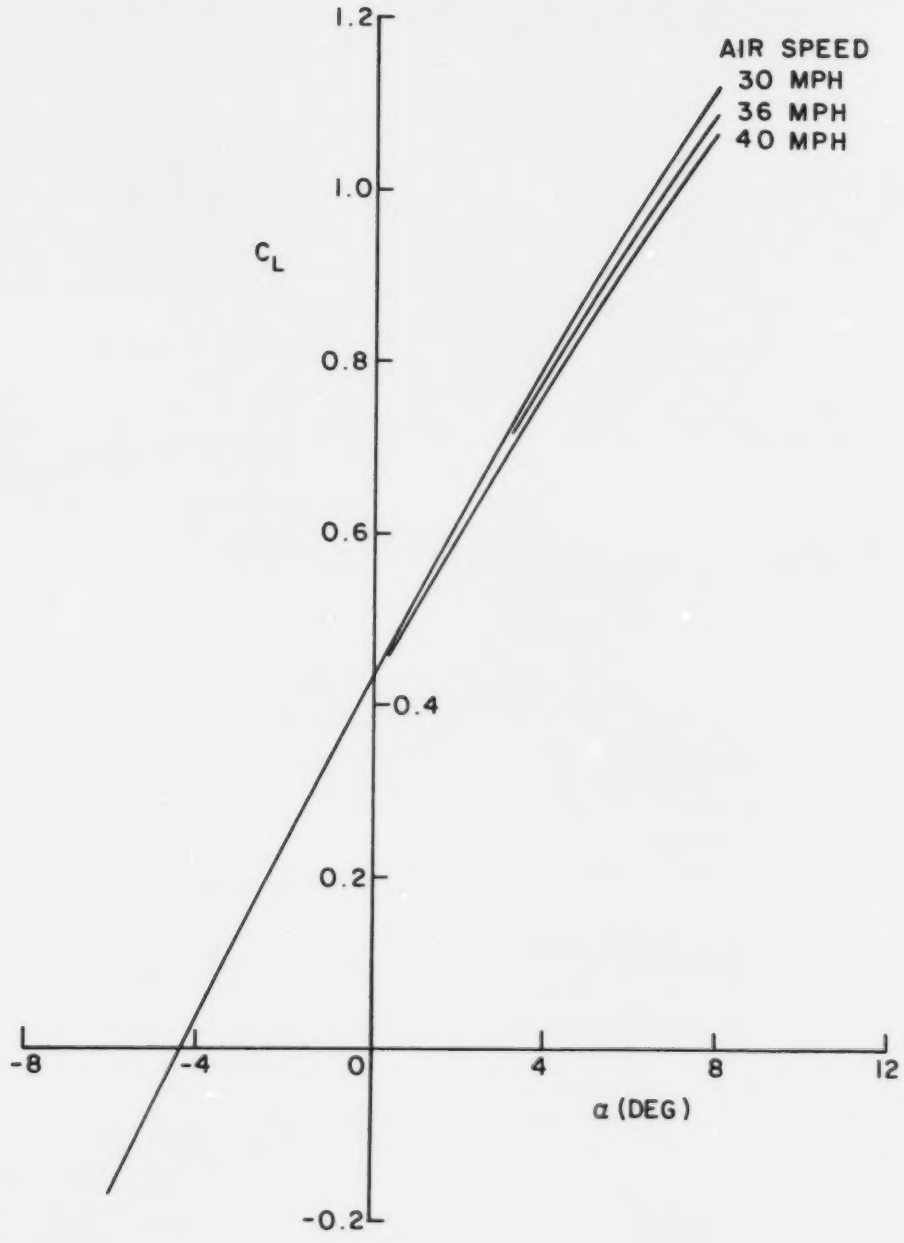
FIG. 8: C_L VERSUS α FOR VARYING q, δ_e MAXIMUM NEGATIVE VALUE

In Figure 8 with the aileron fixed full up the reduction in pitching moment is obvious and there is a slight decrease in lift curve slope with dynamic pressures from 2.3 to 4.1 pounds per square foot. In Figure 9, with the aileron free to float, over the same dynamic pressure range the effects of wing flexibility become more obvious.

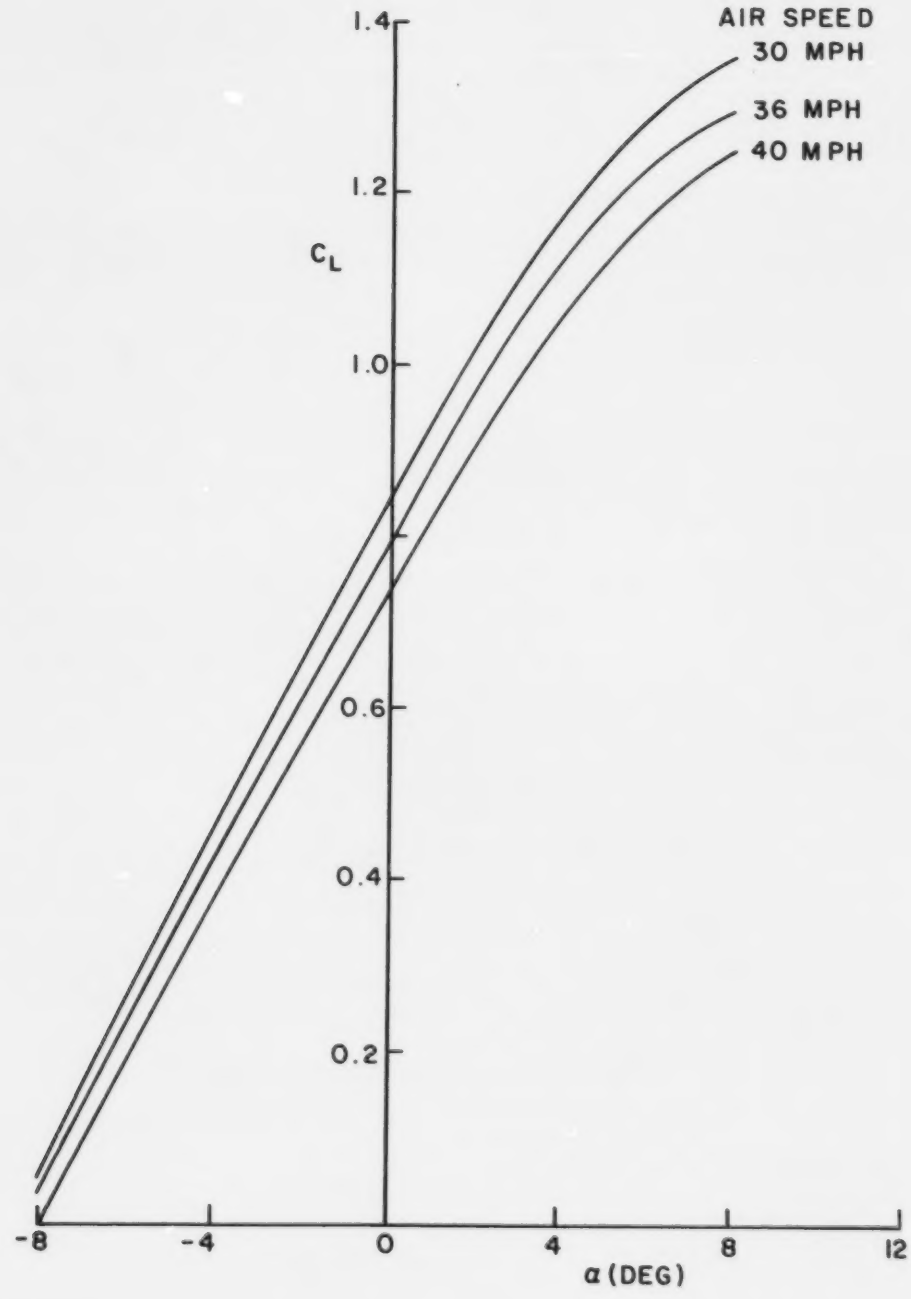
FIG. 10: C_L VERSUS α FOR VARYING q, δ_e MAXIMUM POSITIVE VALUE

In Figure 10 with aileron fixed full down the maximum lift coefficient at $\alpha = 8°$ is, as expected, higher than the other cases. However, the change in maximum value and the change in slope with dynamic pressure are greater then the other cases. With aileron down the decrease in maximum lift coefficient at $\alpha = 8°$ with an increase of dynamic pressure from 2.3 to 4.1 pounds per square foot is 1.1. The same increments for aileron zero and full up are respectively a decrease of 0.8 and 0.55. The maximum value of lift coefficient was marginally greater then the value at $\alpha = 8°$ but the lift curve slope is almost horizontal beyond $\alpha = 8°$ as illustrated in Figure 6 for all wing tests.

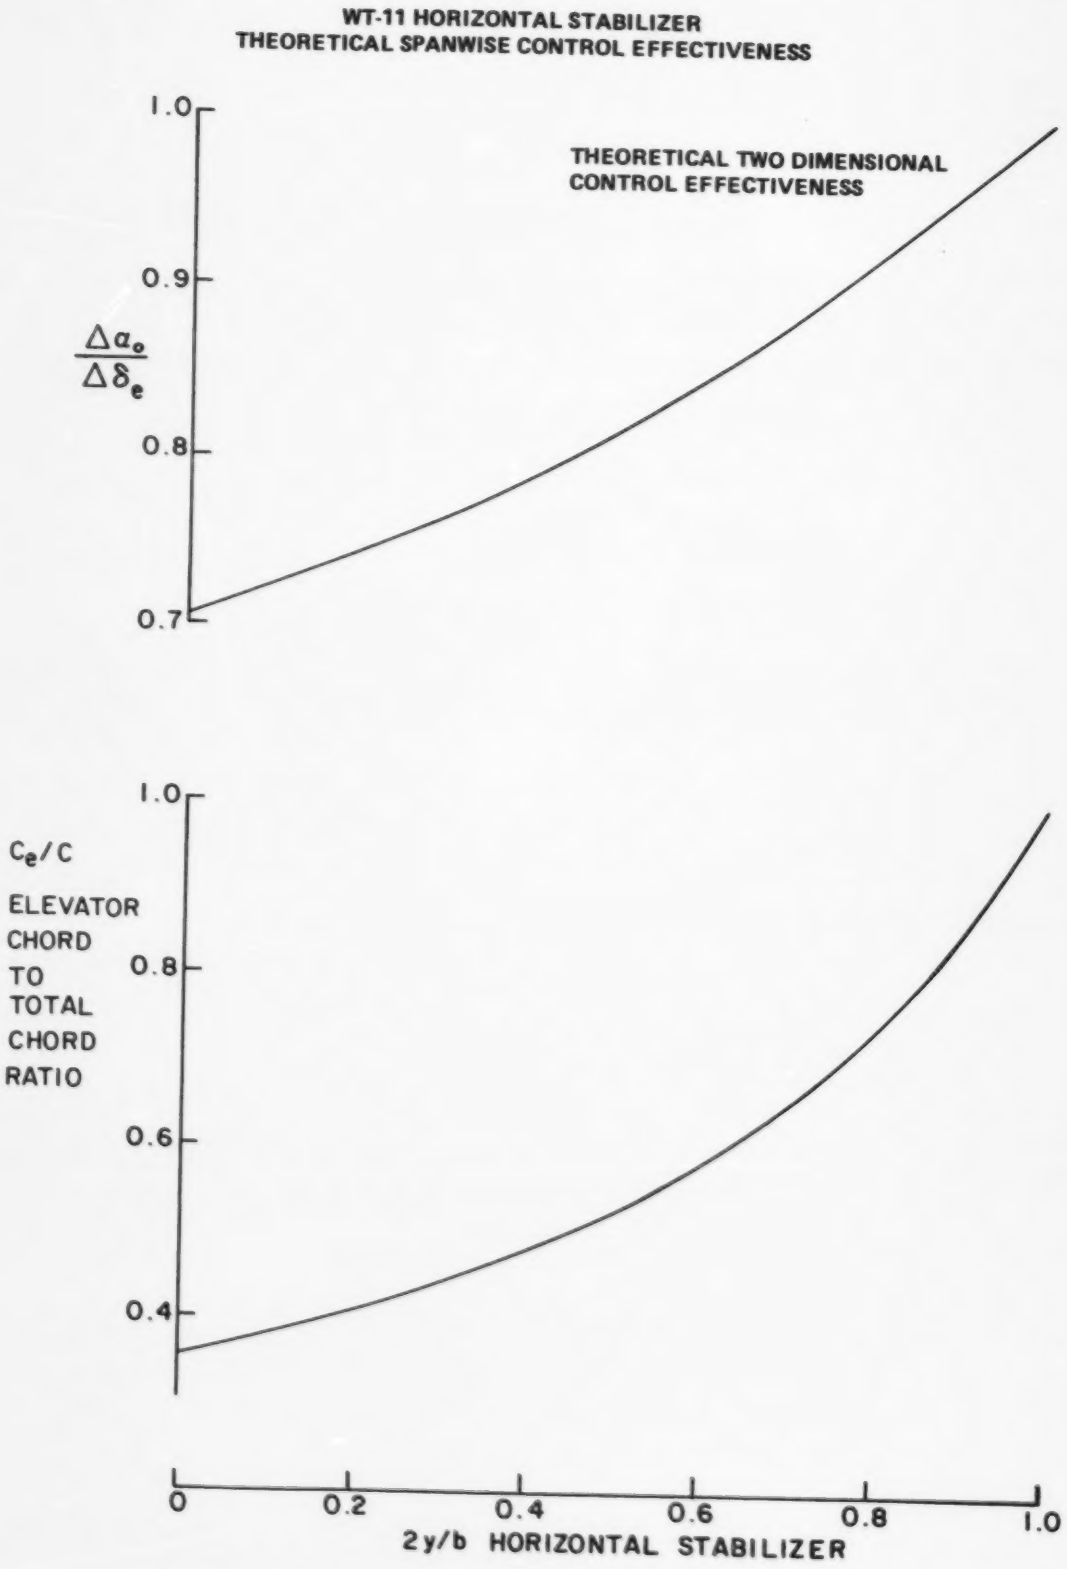
FIG. 11: THEORETICAL $\Delta\alpha°$ VERSUS $\Delta\delta_e$ FOR WT-11 EMPENNAGE

Since the stabilizer tapers to zero chord at the tip while the elevator has constant chord, the theoretical effect is a change in incidence at the tip equal to the elevator deflection while the centre line increment is approximately 70% of the elevator deflection (Fig. 11).

One point that *is* of interest in the geometry of the horizontal tail plane. Since the horizontal stabilizer tapers to zero at the tip and the elevator has constant chord an effective positive spanwise twist is produced by an elevator deflection increasing the effective lift coefficient. This indicates that elevator deflections, adding to tail load produced by incidence, will result in wash-in and tip stall (Fig. 11). This is inherent in this empennage geometry.

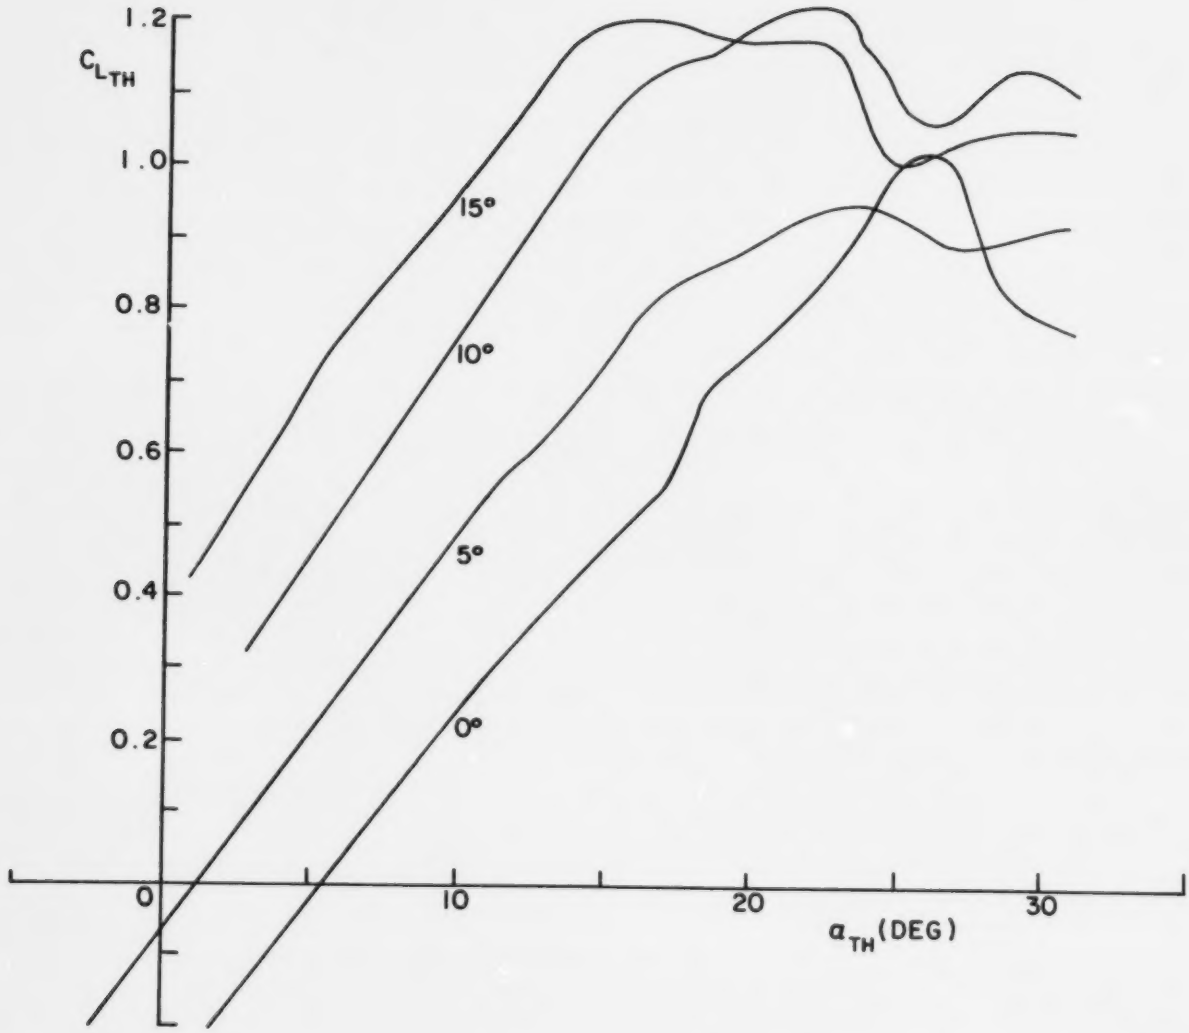
FIG. 12: $C_{L_{TH}}$ VERSUS α_{TH} FOR δ_e VARIED

The result is a large apparent wash-in and at the stall a maximum empennage lift coefficient that actually appears to decrease with increasing elevator deflection (Fig. 12).

The effect of the wash-in on the horizontal tail is to limit the maximum lift coefficient. When incidence and elevator deflection combine to increase effective lift coefficient the values collapse at the stall and effectively limit the horizontal tail control power (Fig. 12).

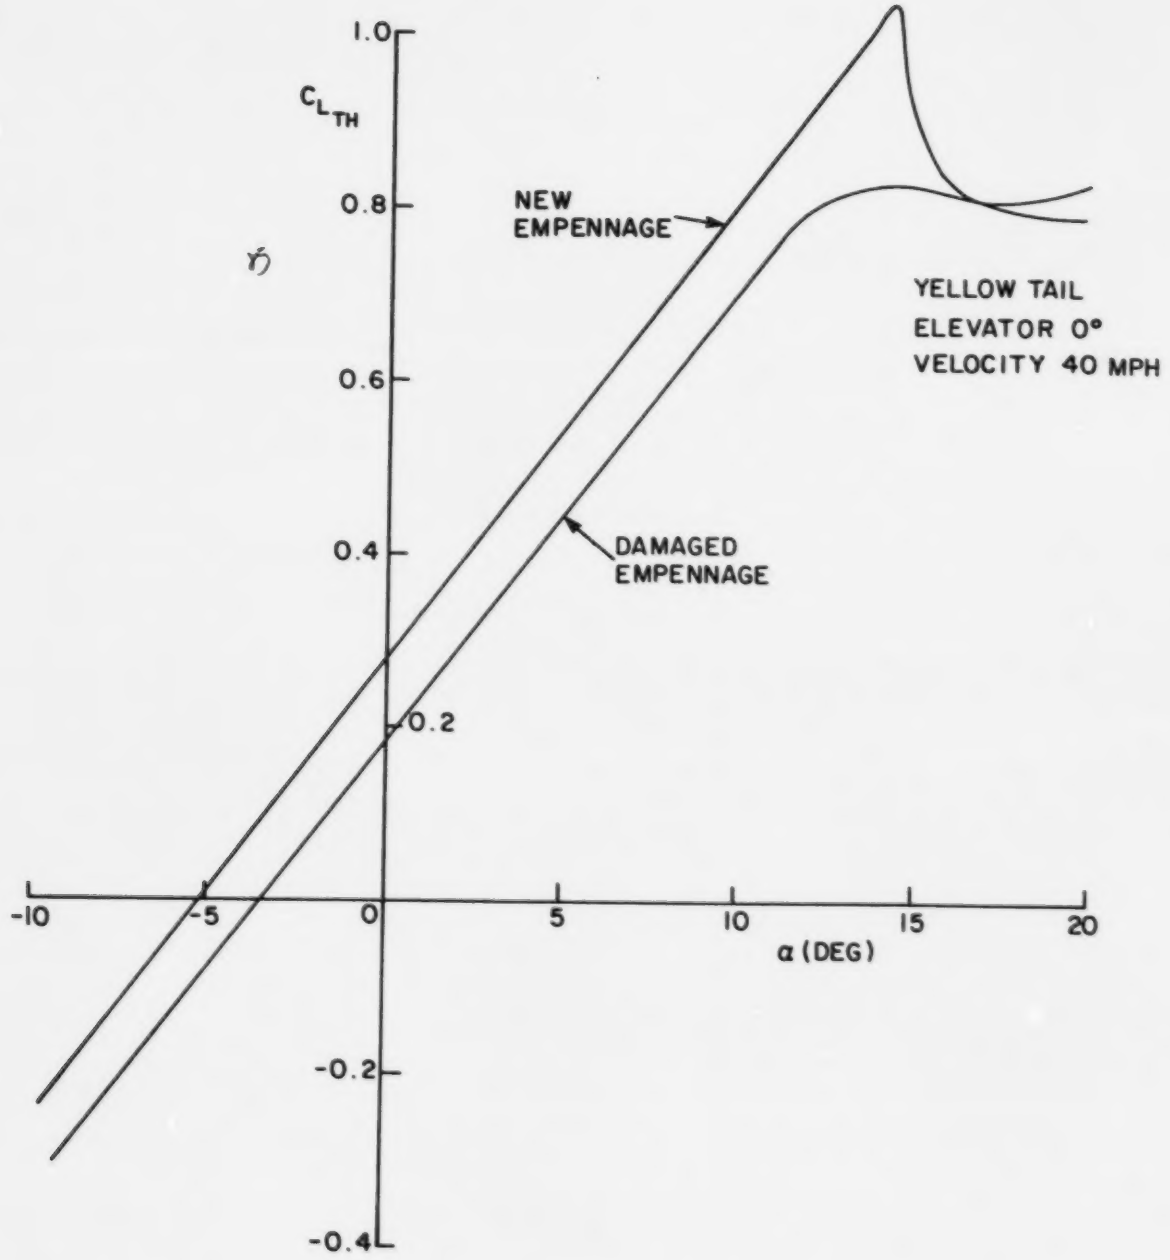
FIG. 14: DAMAGED TAIL ASSEMBLY

The final test runs were carried out on an empennage salvaged from an accident. The fabric was not as taut as that of the initial test specimen, but the lift curve slope was unchanged and values of aerodynamic coefficients were within ten percent of the first tests (Fig. 14).

The comparison of a new and a damaged empennage indicate no change in lift curve slope and aside from the stall the differences can be ascribed to the accuracy of installation in the wind tunnel. The new empennage achieves a slightly higher lift coefficient but has a more violent stall (Fig. 14).

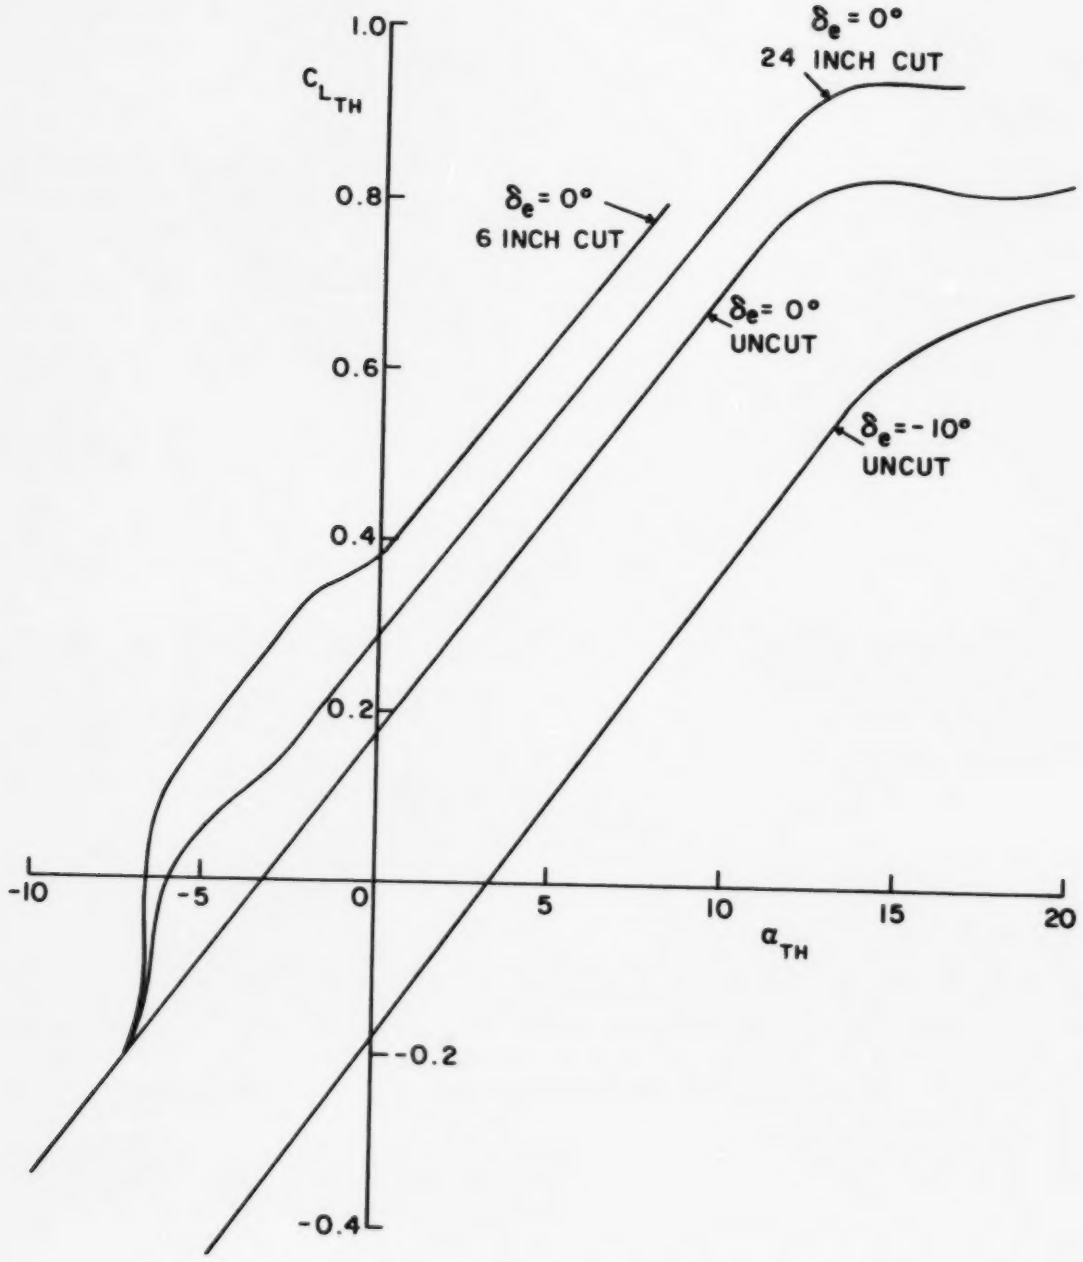
FIG. 15: CUT FABRIC $C_{L_{TH}}$ VERSUS α_{TH}

The fabric on the horizontal stabilizer was then cut along the lower surface leading edge on the starborad side, for approximately six inches. The angle of attack was swept from -8° to $+8^\circ$ fuselage attitude. The cut was then extended for approximately two thirds of the semi-span and the angle of attack was swept from -10° to $+16^\circ$. The lift curves against angle of attack are compared with the uncut tailplane in Figure 15.

Cutting the empennage fabric covering along the leading edge, on the lower surface of the horizontal stabilizer, resulted in a sudden ballooning of the lower surface covering when the effective angle of attack resulted in suction on the lower surface leading edge. The initial six inch cut on one side near the tip resulted in an effective camber change, when the fabric ballooned, equivalent to approximately five degrees of up elevator.

Extending the cut to twenty-four inches resulted in a similar trend but the damage reduced the effective camber change and tended to destroy the flow. The longer cut was only half as effective as the initial six inch cut (Fig. 15). This single test demonstrates that the nature and extent of any damage can be quite critical to horizontal tail effectiveness and can have large effects on longitudinal stability.

Damage to the lower surface could result in pitch up and conversely damage to the upper surface could result in pitch down.
